REPORT NO. SP-665  
DATE 5-14-64  
COPY NO. # 6

**MODEL** A-12

**TITLE** LIGHTNING TESTS - MODEL A-12 PLASTIC RUDDER

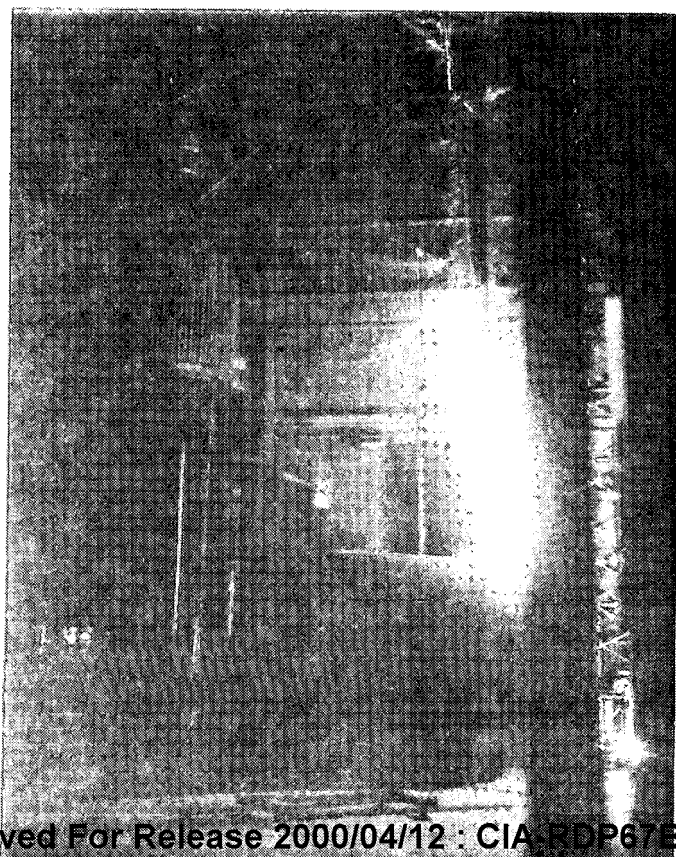
Photo IV-3 Run IV is similar to Run III. Again arc moves along an internal path to ground which could mean potential damage.

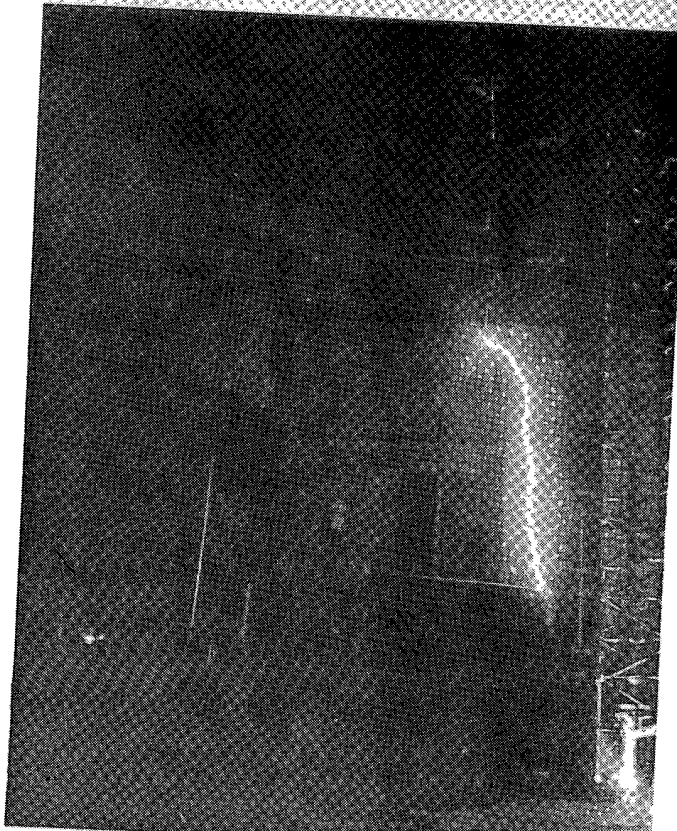
Photo VI-3. Run VI.  
Examination after run  
revealed small puncture  
through Rescon.

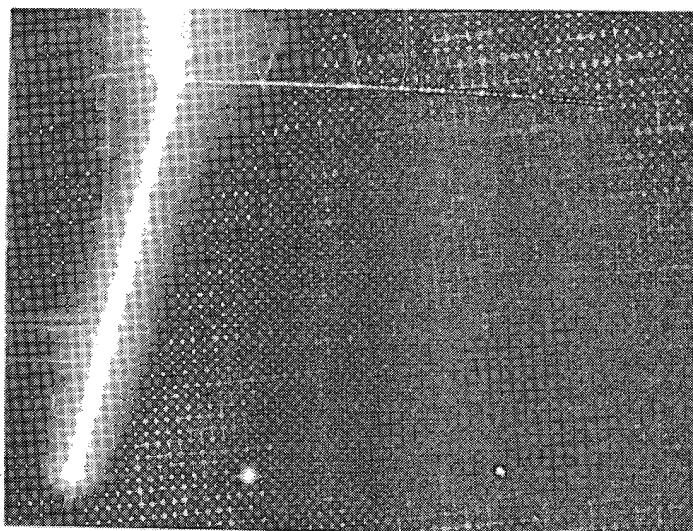
Photo XXI-3. After  
Run XXI. Note burned  
area of leading edge  
in gaps between dipoles.

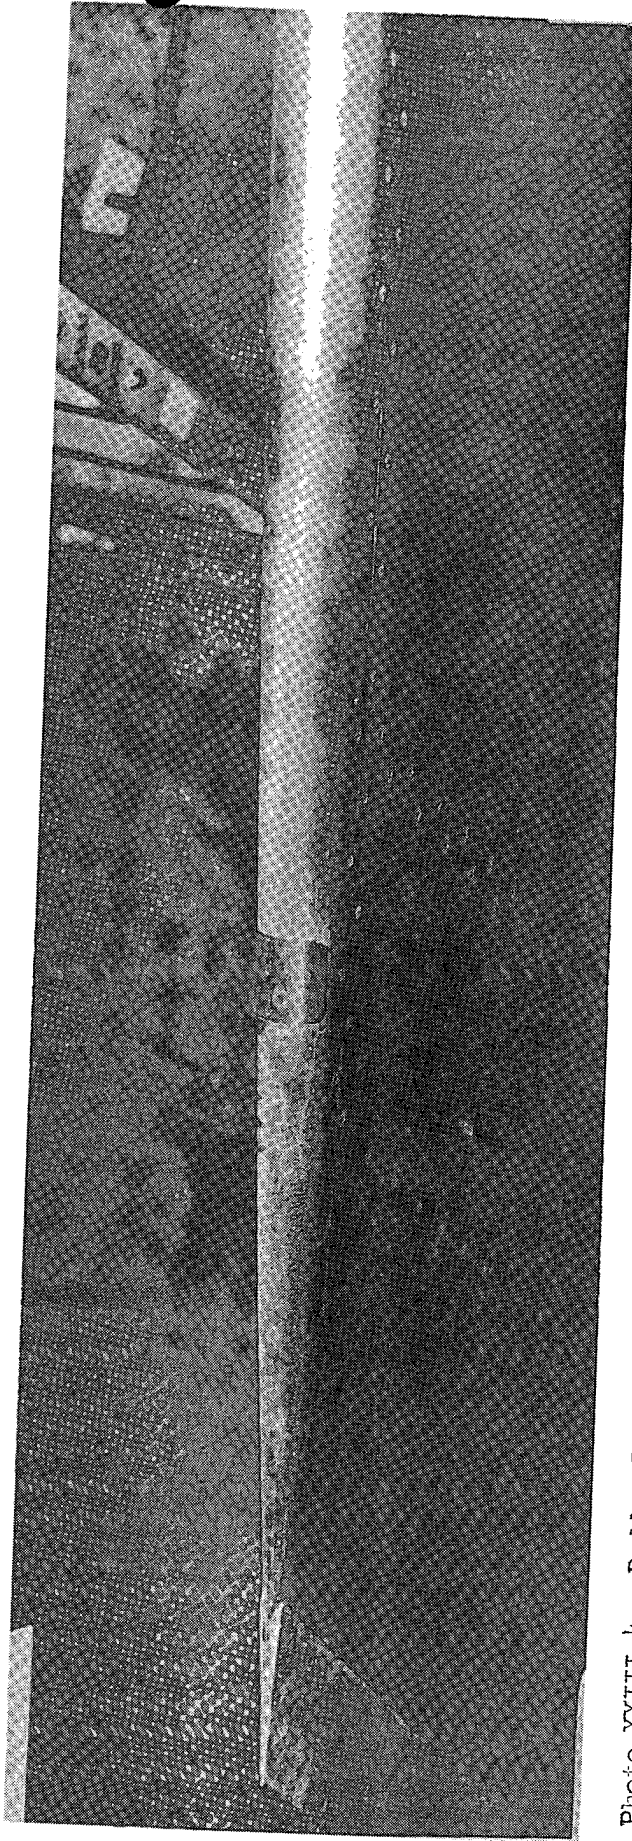
Photo XXIII-4. Rudder L.E. tip with needles removed. Note burned area.

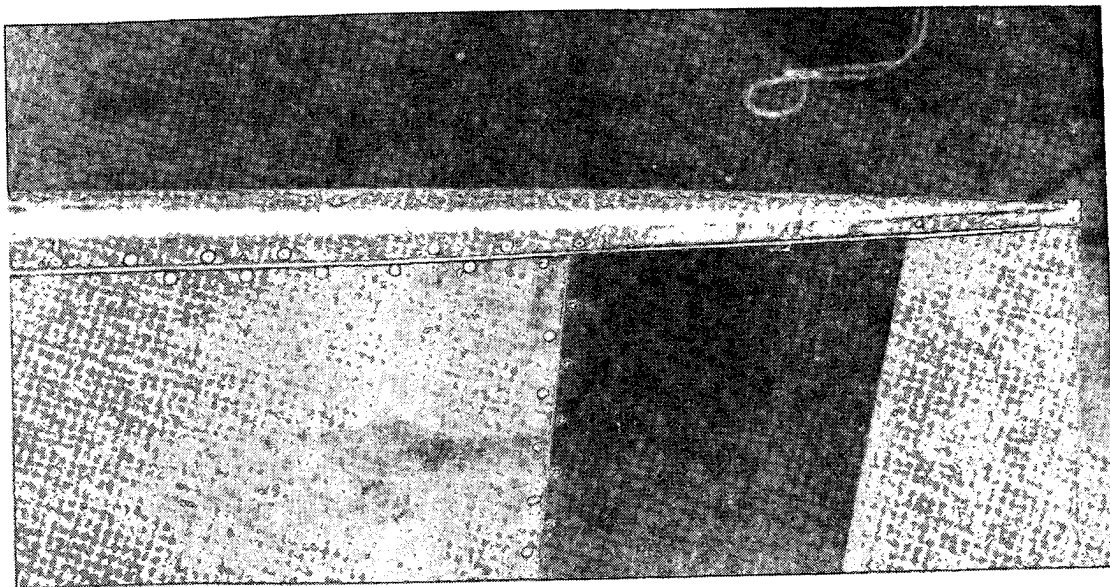
Photo XXVII-5. Rudder tip after Run XXVII. Note tracking. Dark spots are burns from arcs between dipoles used in previous runs.

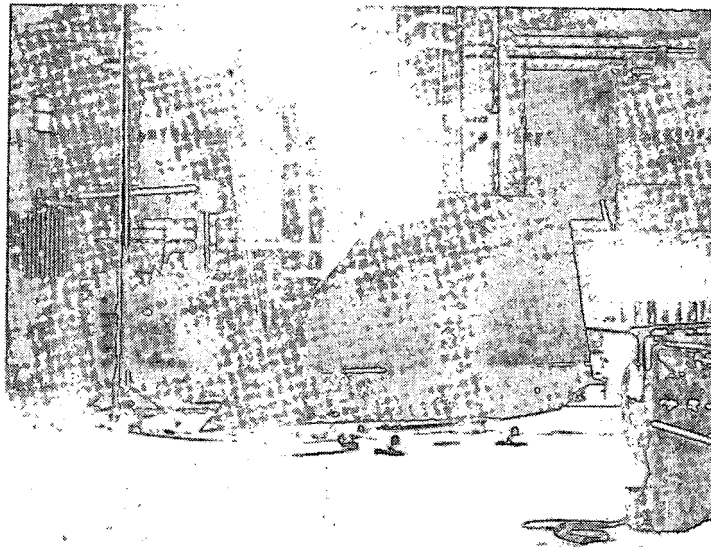
Photo XXVIII-2. Same as above. No visible external damage except for tracking on top.

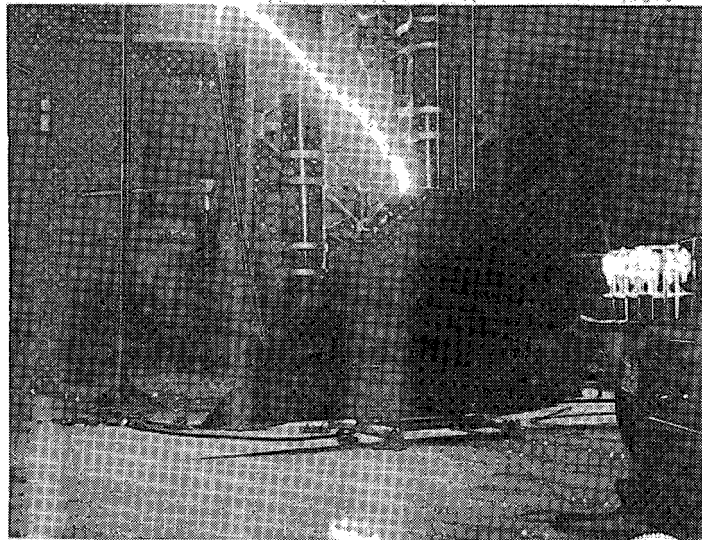
Photo XXIX-2. L.H. side  
Note puff of smoke along  
L.E. which located  
negligible damage area.

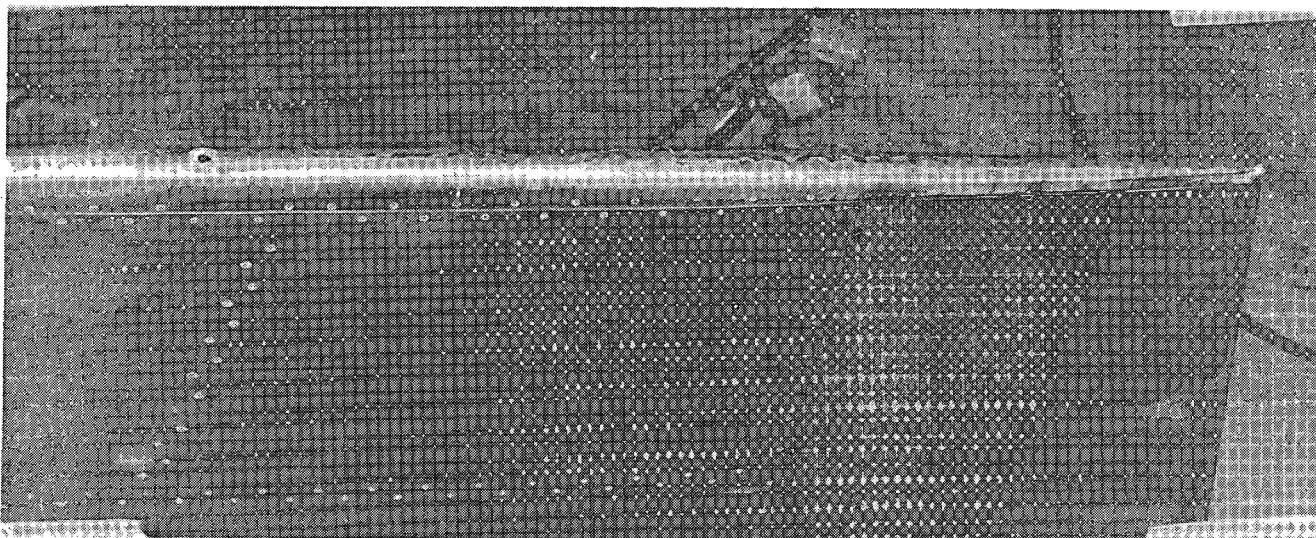
Photo XXX-5. Rudder tip - Note tracking and blown out patch.

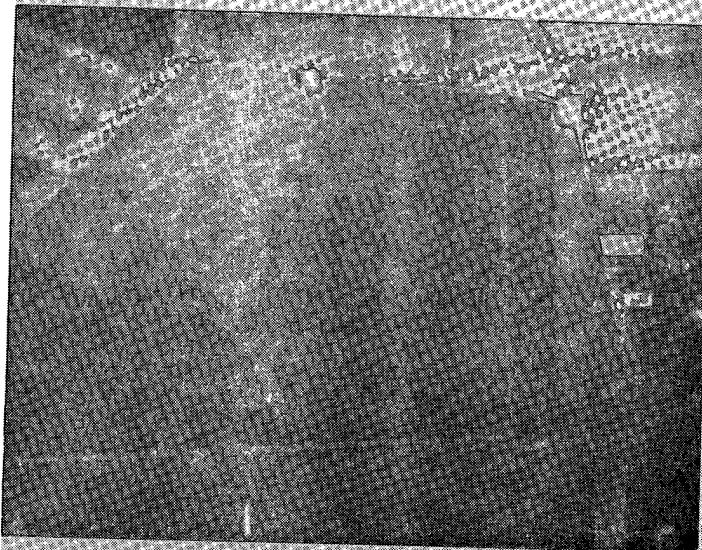
Photo 1-1. Run 1.  
Note emergence of  
arc at about 30 percent  
chord point on tip.  
Slight damage.

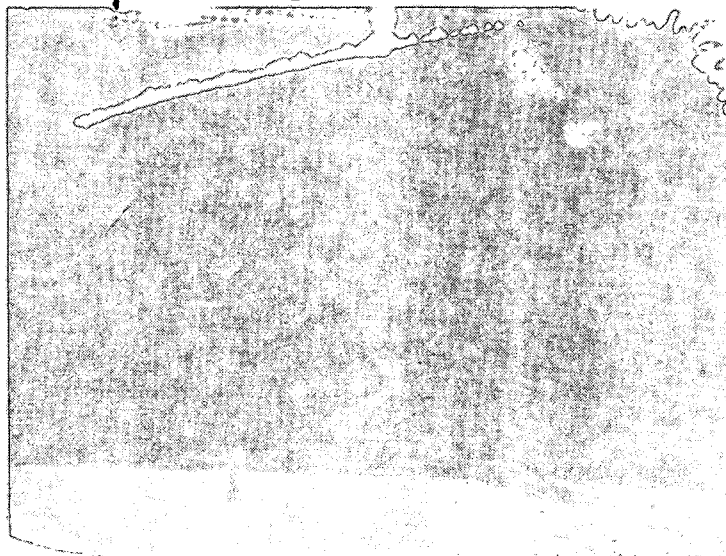
Photo 6A-1. Run 6A.  
Gaps between tapes had  
widened due to arcing.  
Note puff of smoke on  
L.E. where slight damage  
occurred.

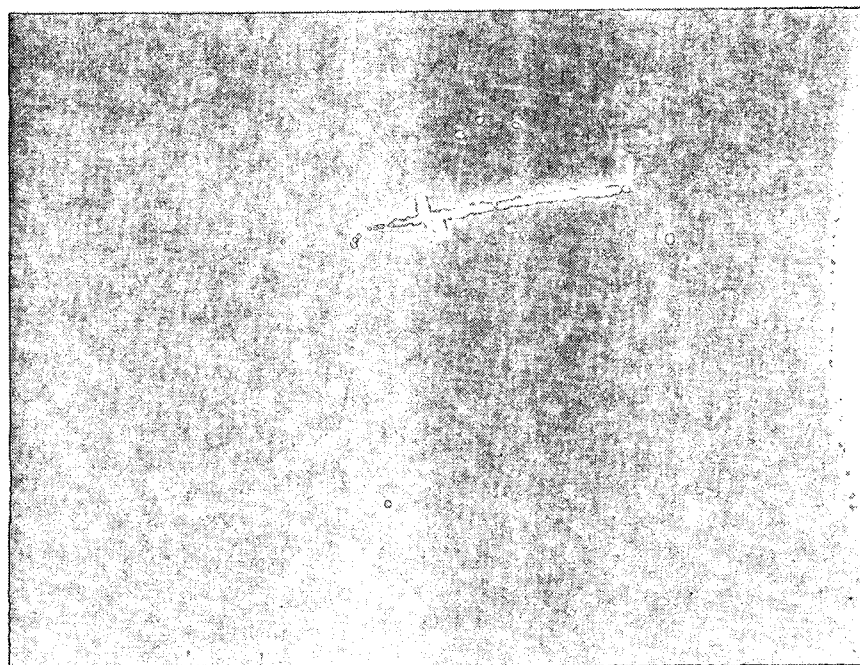
Photo 6A-3.  
Note "puff of smoke"  
area. Slight damage  
found.

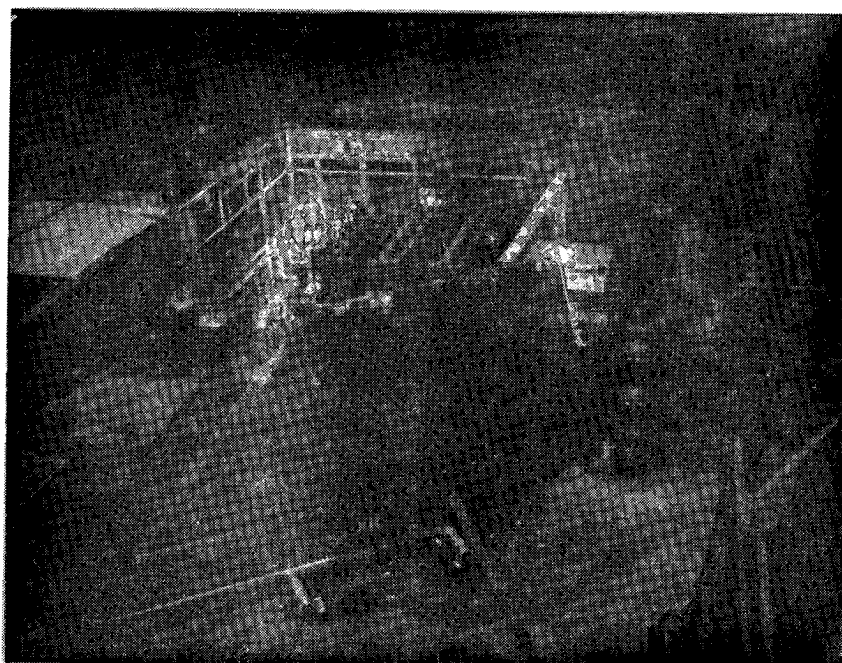
Photo 12-2. Puffs of smoke above post area locate missing jo-bolts.

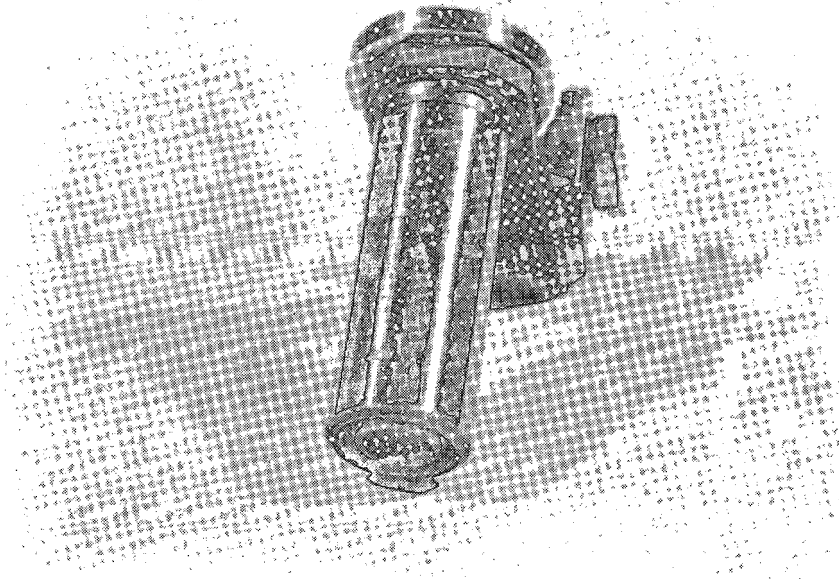
Photo C -Additional pitted area on link pin. The pin had to be forcibly removed from the actuator link spherical bearing after completion of the test.
